Inspection report

Road: OLD STREET ROUNDABOUT	Map No.1:	start MH: RG1
Place: LONDON	Map No.2:	end MH: MH7
Location:	Tape No.: 00029	Total length: 8.1 m

Purpose:	Shape/Size: Circular 150
Section use: surface water	Material: Vitrified Clay Pipe length:
Catchment:	Lining:

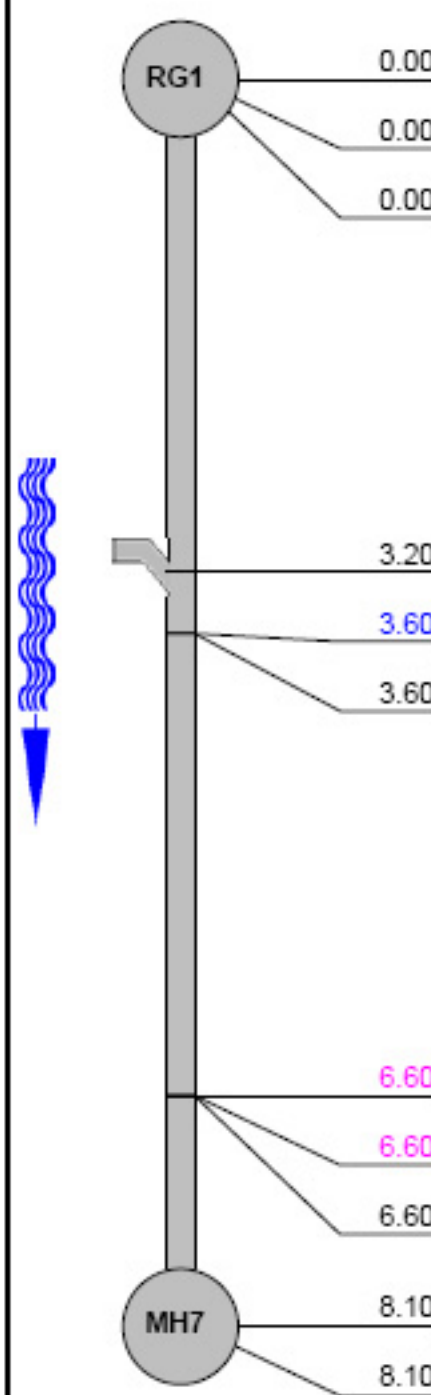
0.00	ST	Start of Survey		0
	0.00	MH	Manhole Remark: RG1		0
	0.00	WL	Water level, 5 % height/diameter		0
	3.20	JN	Junction at 03 o'clock, dia 150 mm		0
	3.60	JDL	Joint displaced. Large

2
	3.60	LD	Line of Sewer deviates down		0
	6.60	H	Hole in sewer from 07 to 08 o'clock

4
	6.60	FM	Multiple Fractures from 12 to 12 o'clock		4
	6.60	LD	Line of Sewer deviates down		0
	8.10	MH	Manhole Remark: MH7		0
	8.10	FH	Finish Survey		0
